9. Old municipal pasture and municipal kennel

9.1 Basic information

9.2 Background

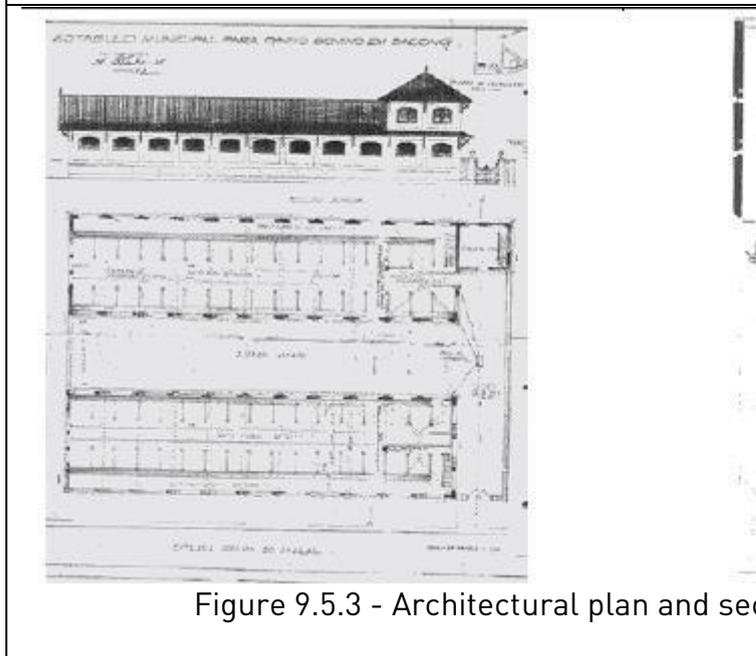
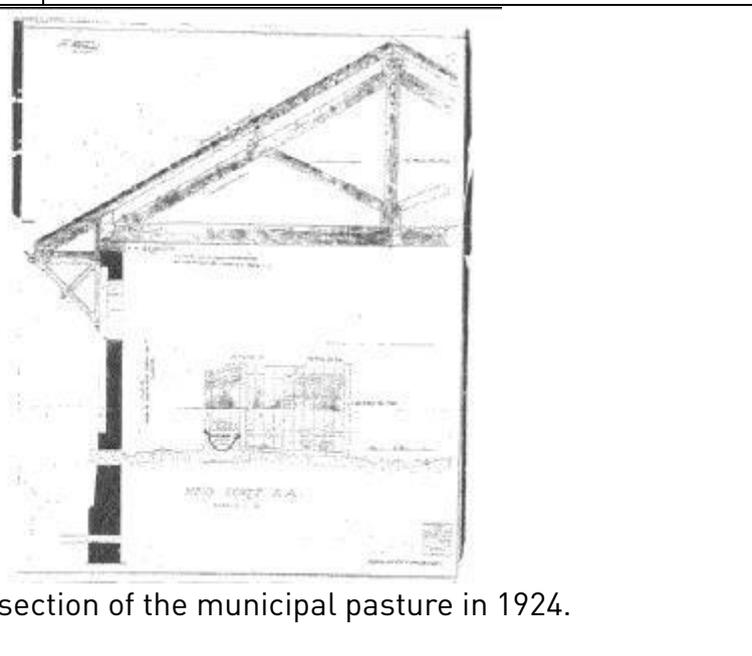
Figure 9.5.3 - Architectural plan and section of the municipal pasture in 1924.

In 1924, the site was rebuilt with two single-storey buildings. With the red roof and the yellow façade, the Portuguese architectural style could be easily identified (Figure 9.5.3, 9.5.5, 9.5.10, 9.5.11). Further, its building height, layout, and drainage system is largely informed by the architectural regulation at the time new buildings were designed to the standard established by the “Private Buildings and Macau Urban Sanitation act” in 1912 (Figure 9.5.12)⁶.

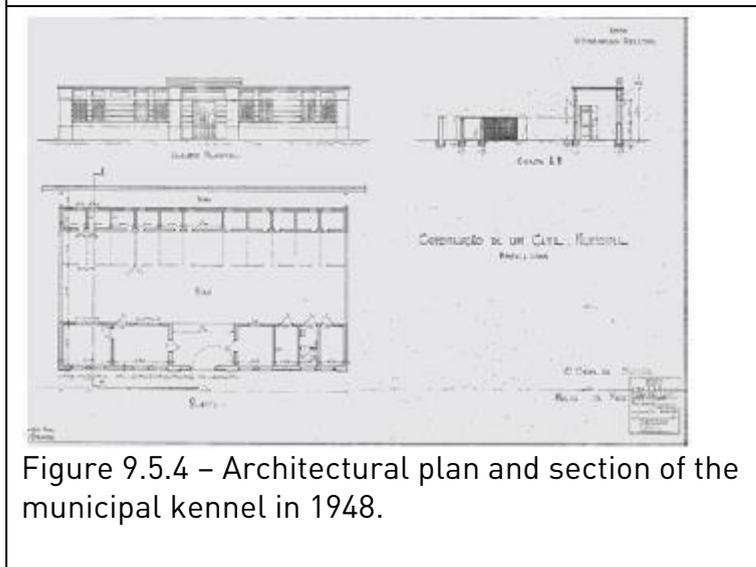
Figure 9.5.4 – Architectural plan and section of the municipal kennel in 1948.

Initially established in 1875, the municipal kennel was situated at Calçada do Tronco Velho until 1908. However, due to the rapid outbreak of canine rabies, the kennel was in dire need of expansion; resulting in its relocation to the current site in 1948 (Figure 9.5.4). The municipal kennel has since served to provide veterinary outpatient service, detention, epidemic prevention injection, and licensing (Figure 9.5.8). The municipal kennel played an active role with effective measures in the resistance effort against canine rabies outbreak during the 1950s; resulting in no resurgence since.

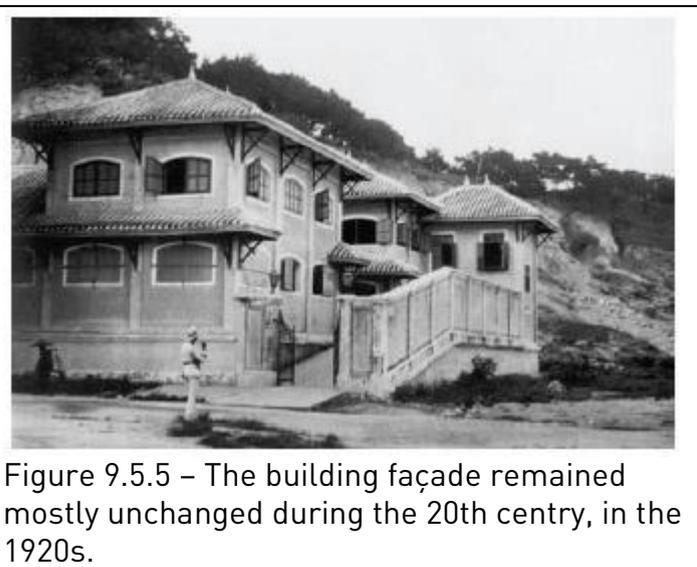
Figure 9.5.5 – The building façade remained mostly unchanged during the 20th century, in the 1920s.

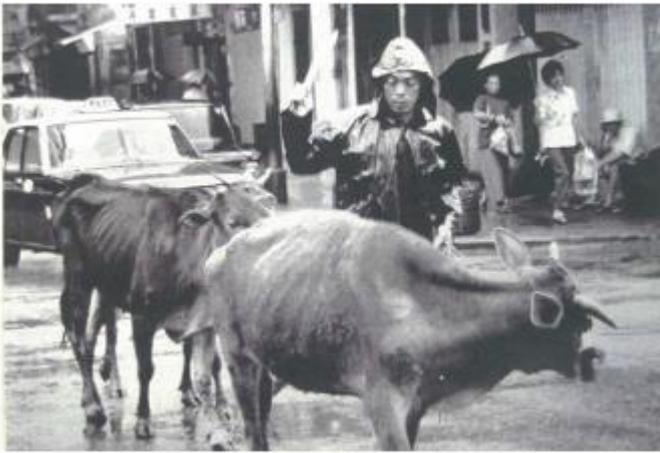
Figure 9.5.6 – Cattles were commonly seen traversing between the municipal pasture and the municipal abattoir at Barra.

Imported cattle stock at the time were required to be inspected by qualified vets at the Old Municipal Pasture before they could be distributed to the local markets; as such, cattle were commonly seen being transported around the vicinity (figure 9.5.6). With the municipal abattoir and pasture relocated to Ilha Verde (Cantonese: Cing-Zau) in October 1987, the site was eventually converted for storage purpose and partially retrofitted as an exhibition space.

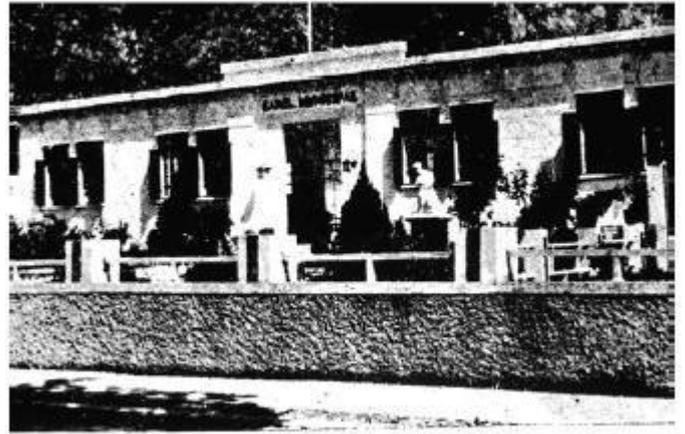
Figure 9.5.7 – masonry sculptures at the municipal kennel garden are well intact up to now.

The municipal kennel is a reinforced concrete building, featuring symmetrical facade equipped with decorative columns and horizontal lines. The Wall is further characterised by geometric elements with prominent layering composition (Fig. 9.5.7) - a common decorative art style building style in Macau in the middle of the 20th century. The dog residence of the original municipal kennel and the dog Inspection Institute built in 1953 has now been demolished and rebuilt (figure 9.5.9), however, the main building with a decorative art style facade is still intact up to now.

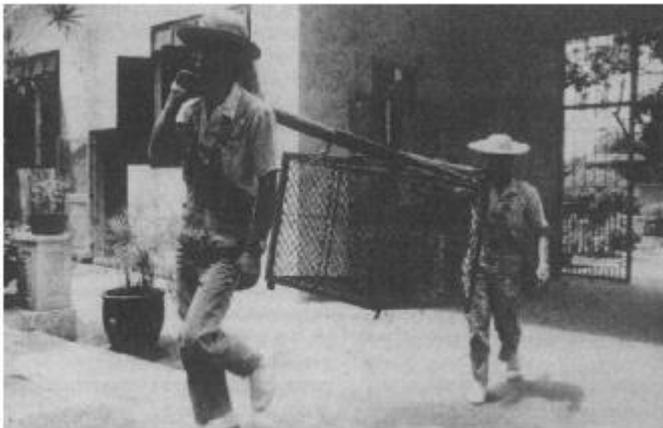
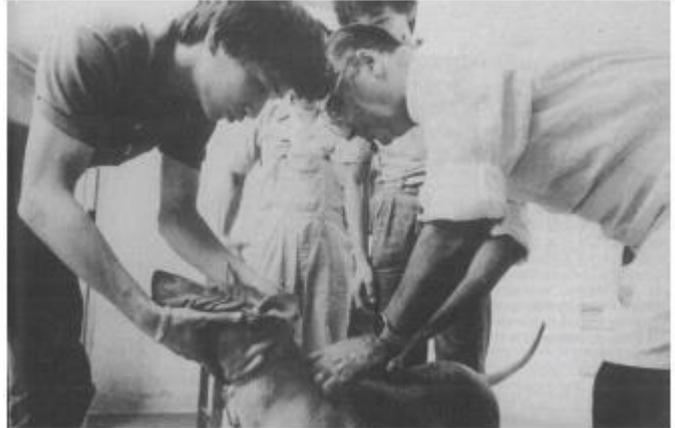
Figure 9.5.8 – Tools used for capturing dogs and in the 20th century 1920s and the veterinary staffs administering an inspection.

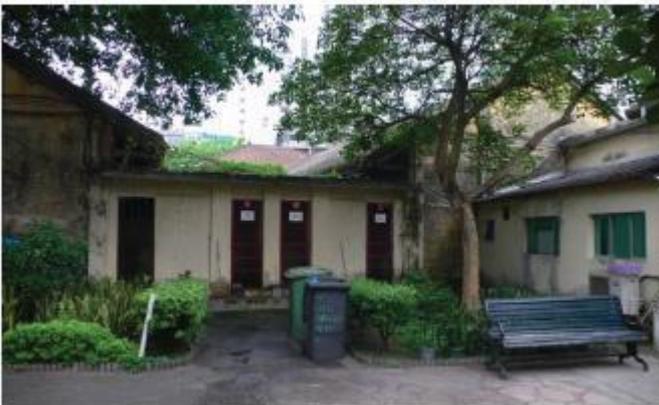
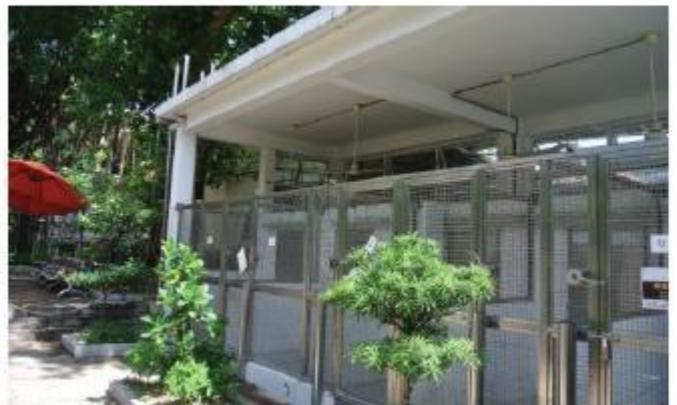
Figure 9.5.9 – Original outlook of the dog residency (left); and its current state (right)

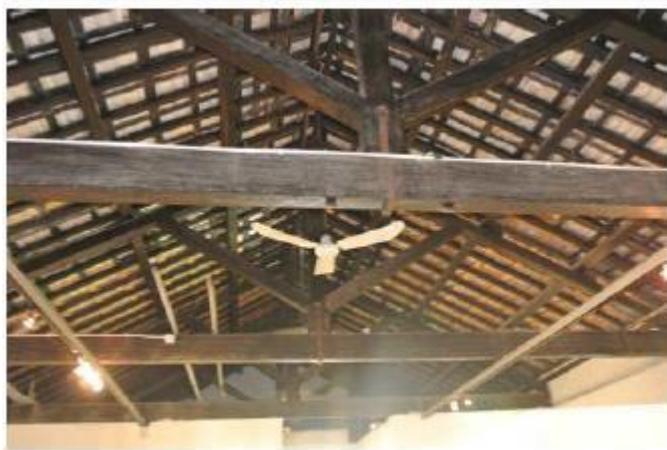
Figure 9.5.10 – roof of the former municipal pasture.

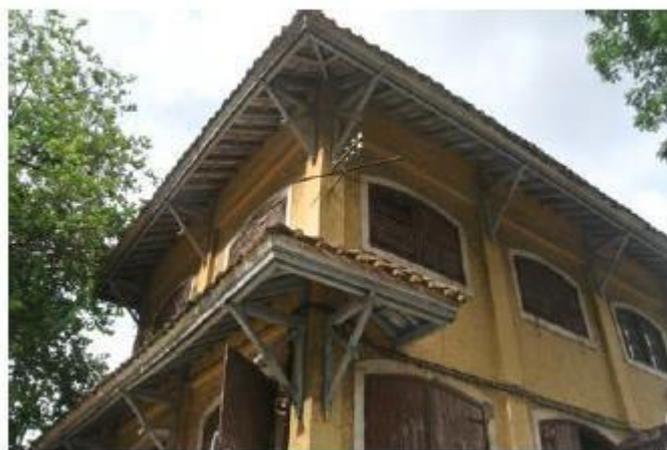
Figure 9.5.11 – the exposed roof eaves and structure, with triangular support, raw finished stucco and arched windows.

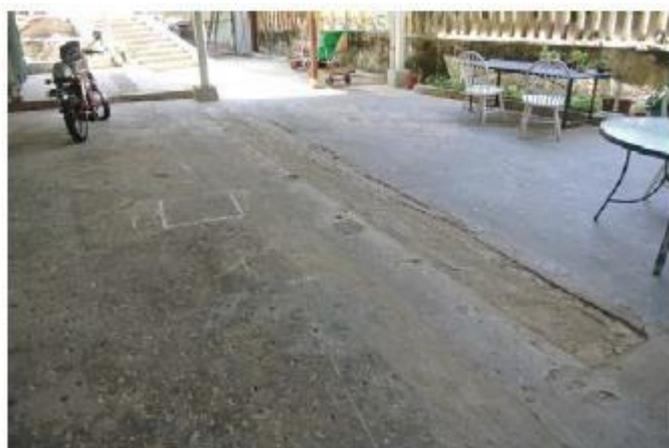
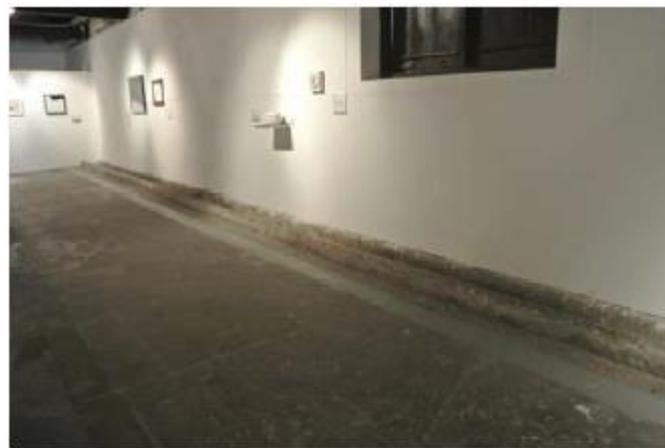
Figure 9.5.12 – The feed through inside the municipal pasture has remained intact up to now, however the feed through at the backyard has since been demolished or repurposed.
